PBU Liner At Corner  
By-Pass Girts

PBU Liner At Flush Corner Corner  
Column Depth Exceeding Girt Depth

PBU Wall Liner  
Flush Interior Colum

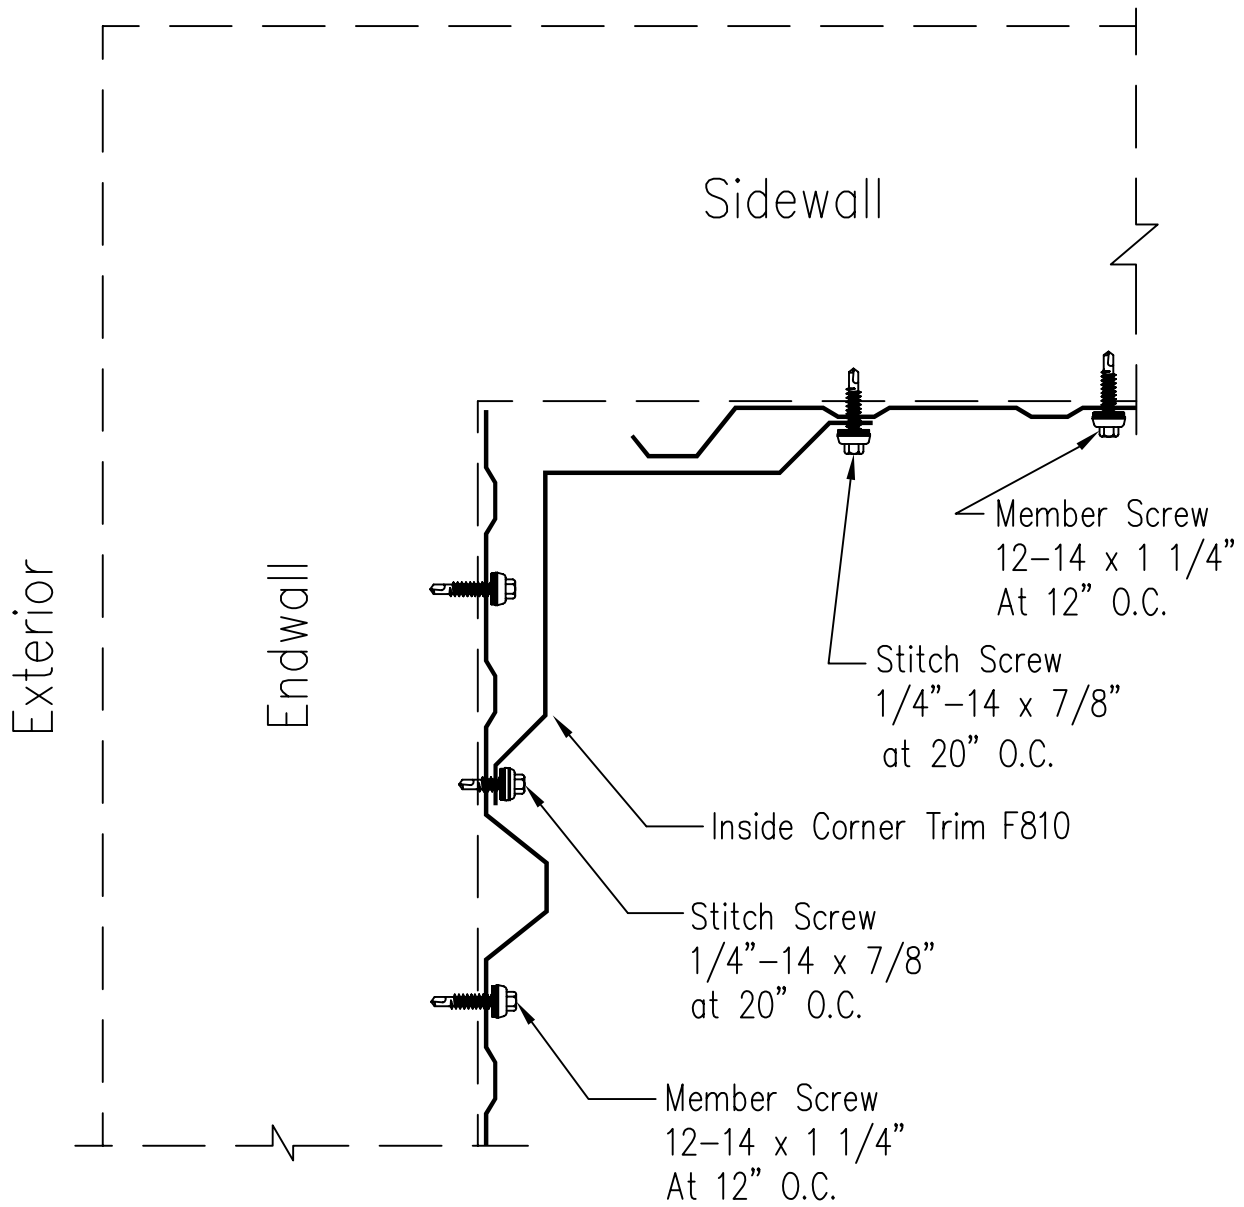
SHT. NO. UL01002	
DATE Jan. 09	REV. 00

This drawing refers to liner conditions only. Refer to additional details for exterior sheeting and trim conditions.

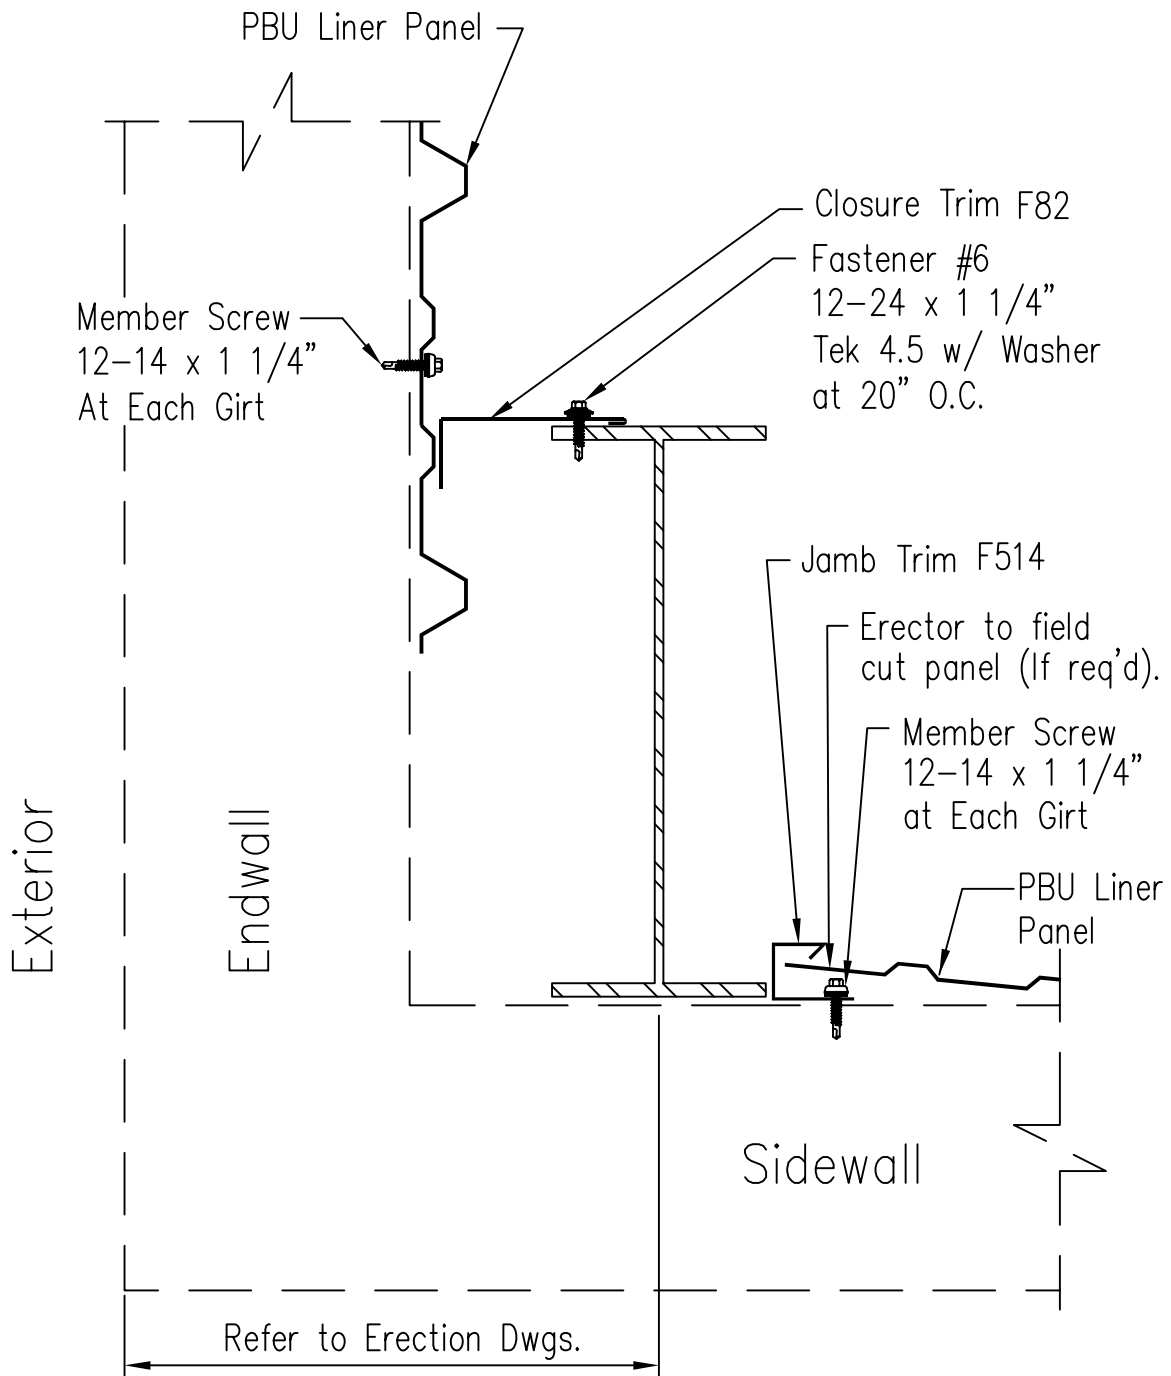
SHT. NO. UL01003	
DATE Oct. 09	REV. 01

This drawing refers to liner conditions only. Refer to additional details for exterior sheeting and trim conditions.

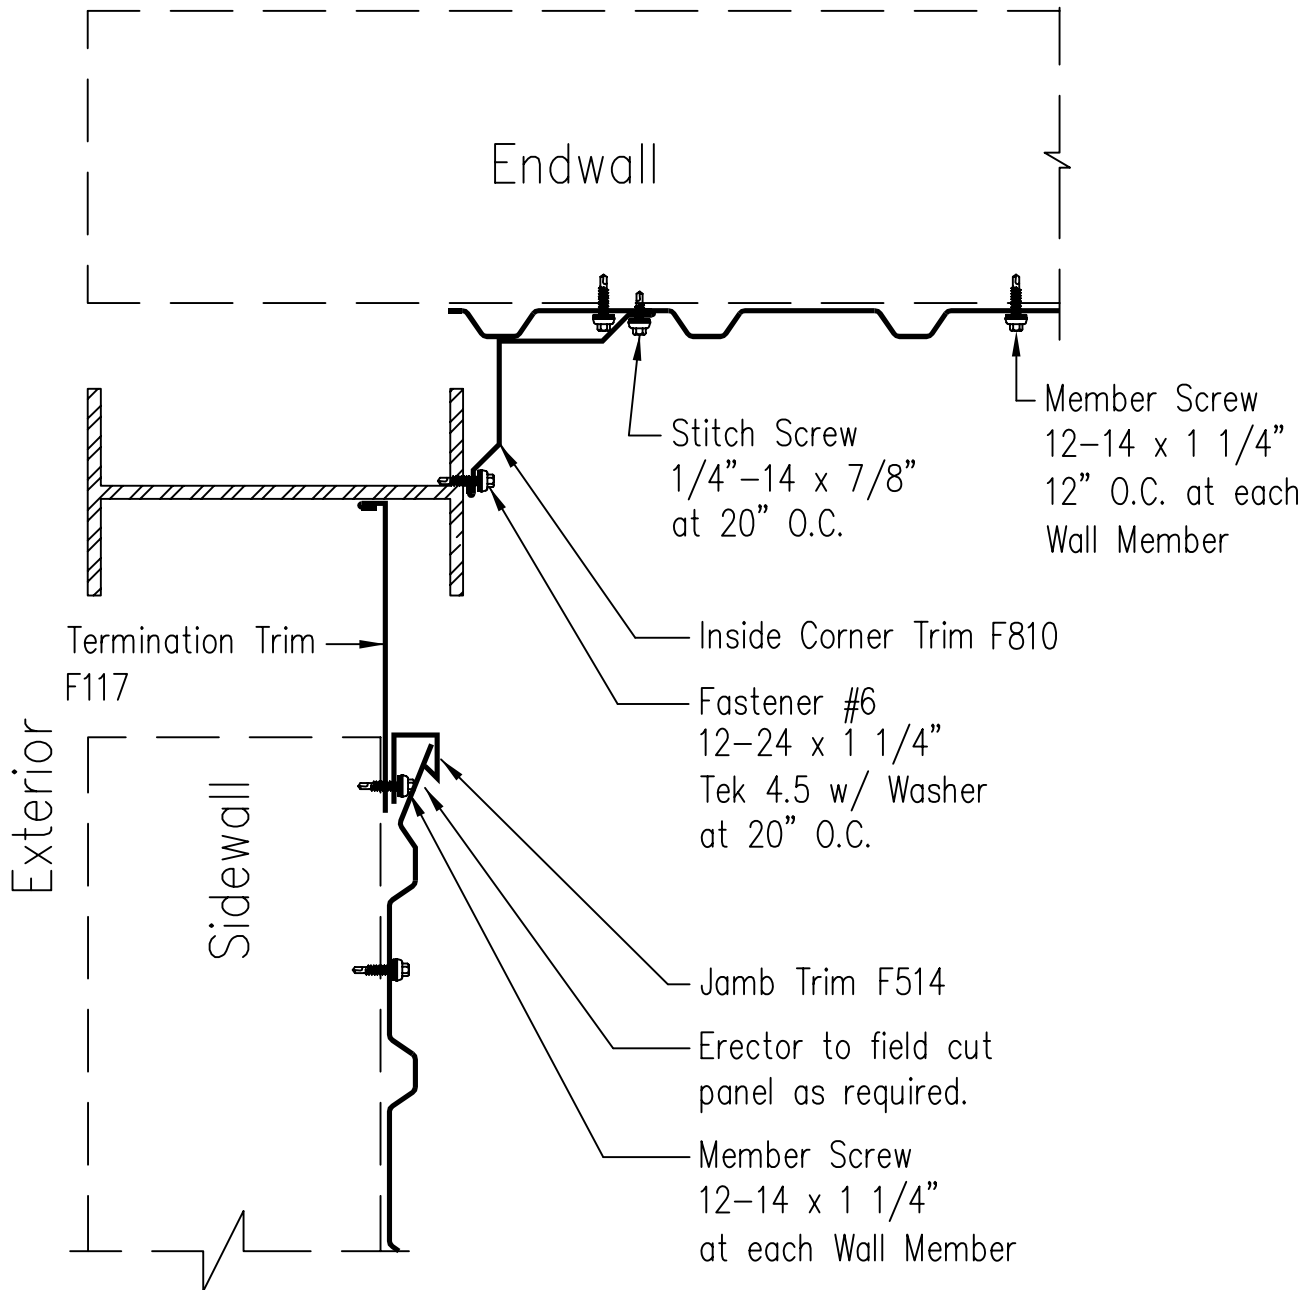
SHT. NO. ULO1004	
DATE Oct. 09	REV. 01

This drawing refers to liner conditions only. Refer to additional details for exterior sheeting and trim conditions.

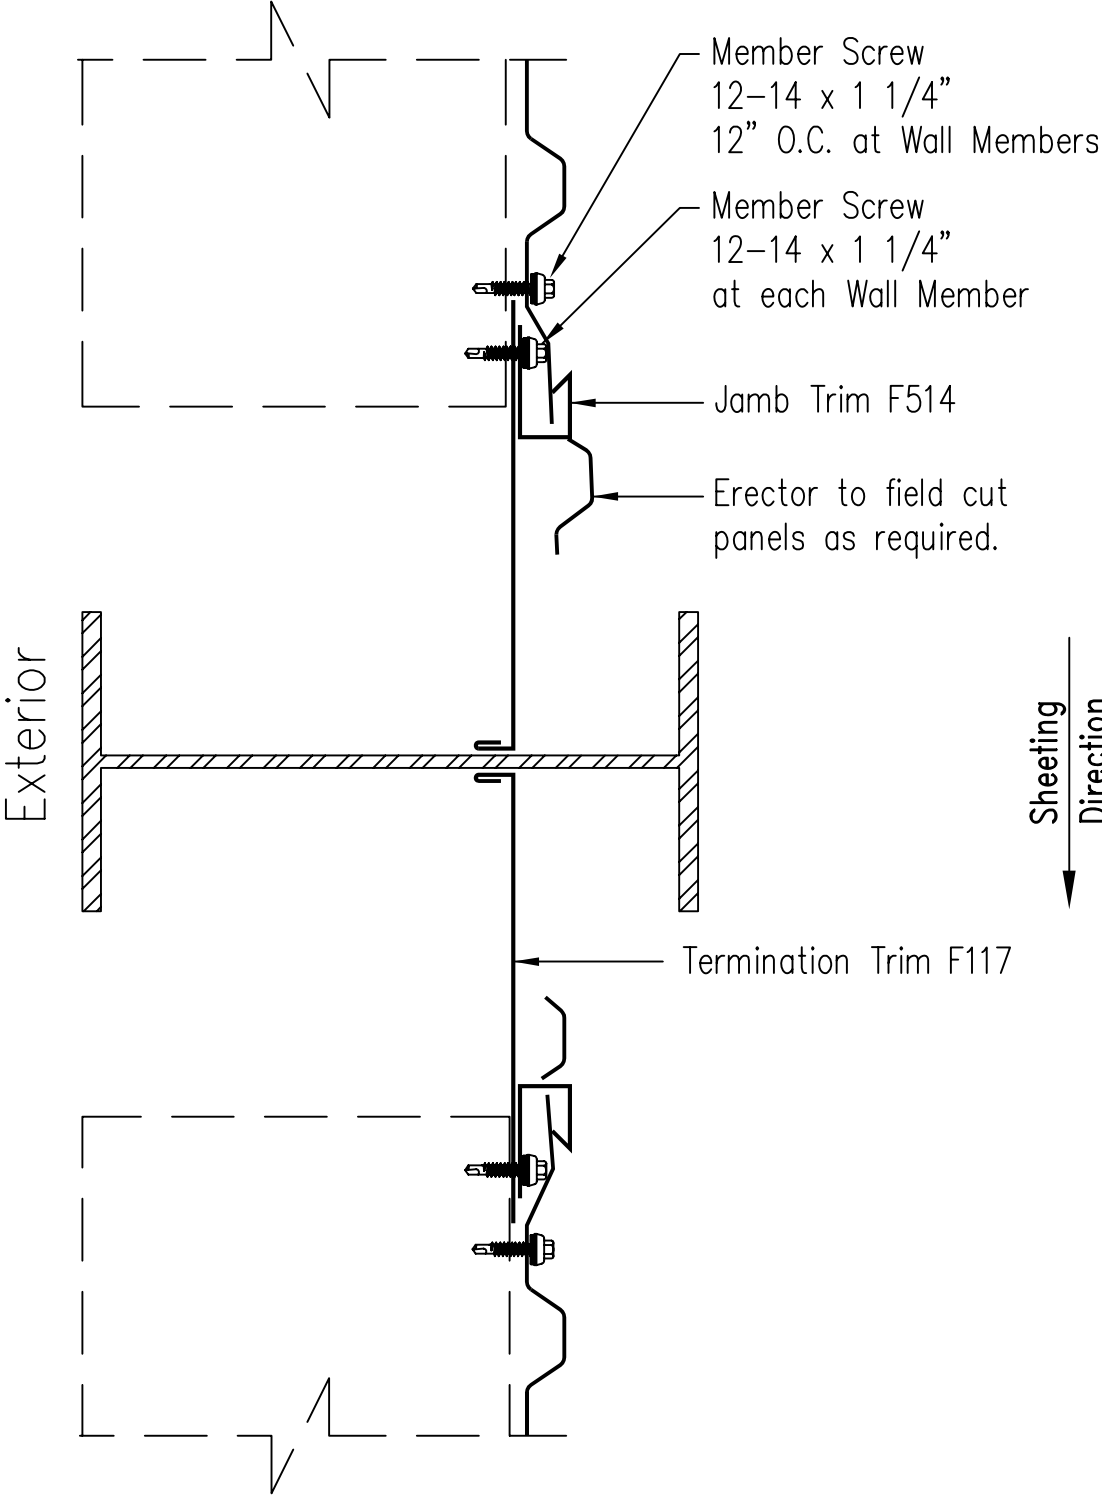
SHT. NO.  
UL01005

This drawing refers to liner conditions only. Refer to additional details for exterior sheeting and trim conditions.

PBU Wall Liner  
Interior Coumn By-Pass Girts

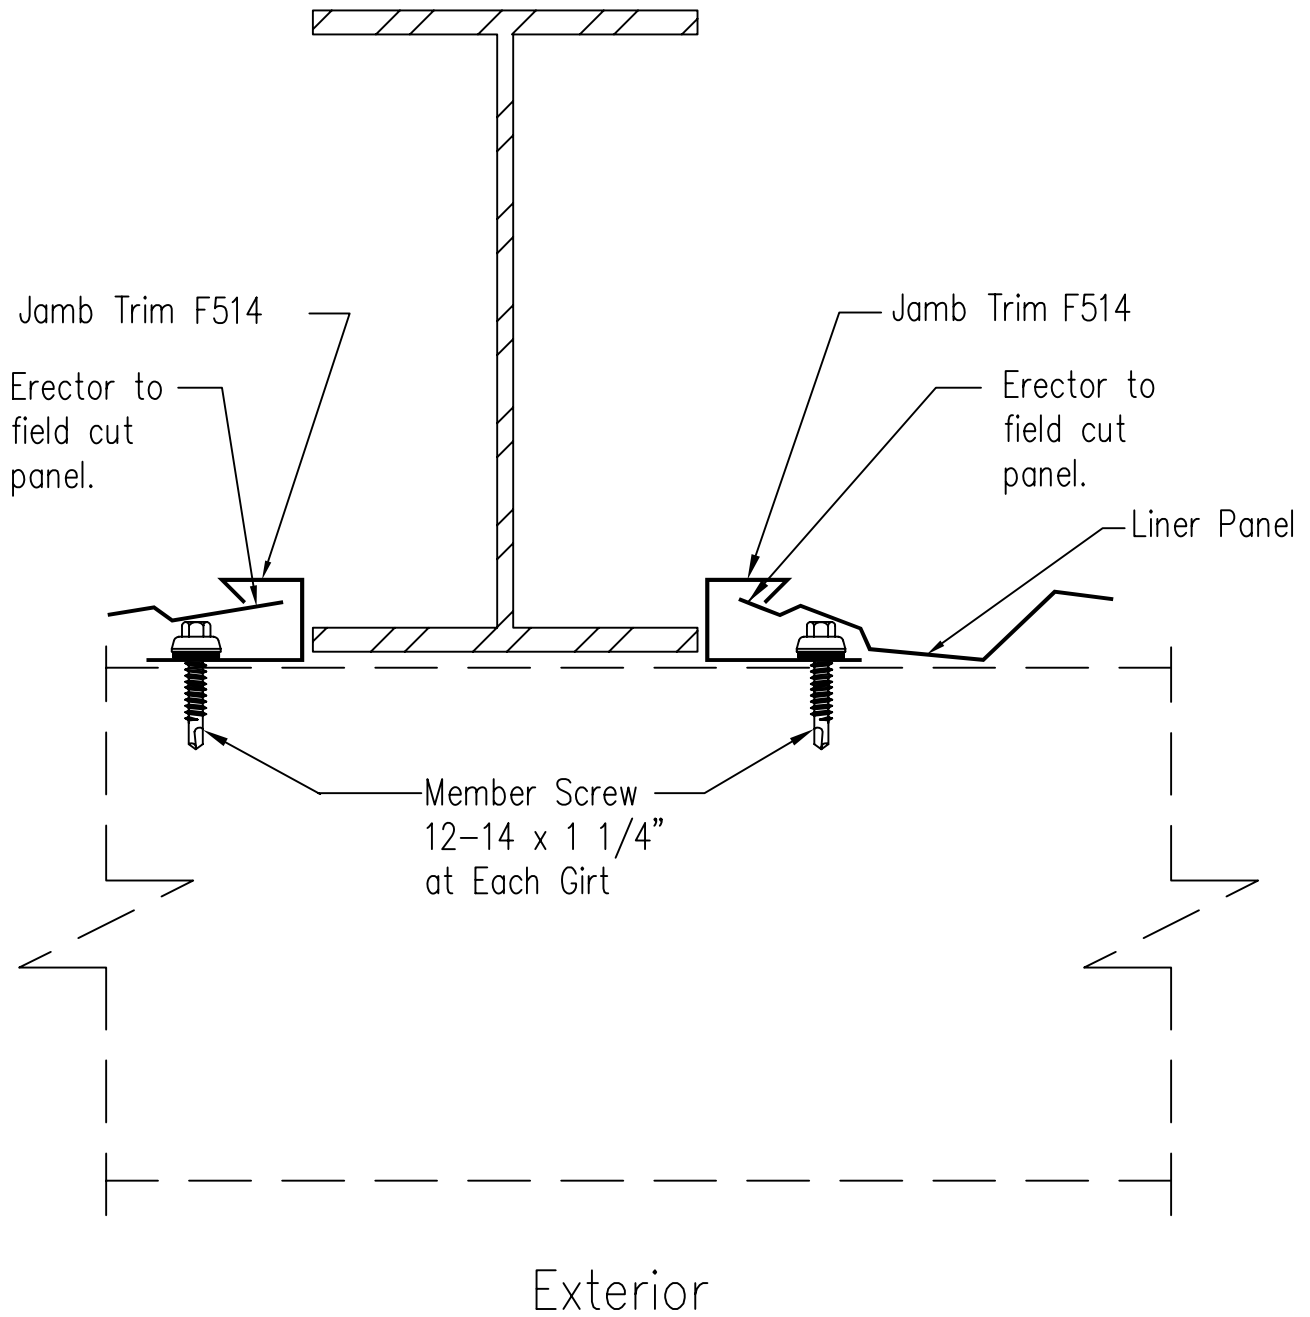
SHT. NO. UL01006	
DATE Oct. 09	REV. 01

This drawing refers to liner conditions only. Refer to additional details for exterior sheeting and trim conditions.

PBU Wall Liner  
Full Height

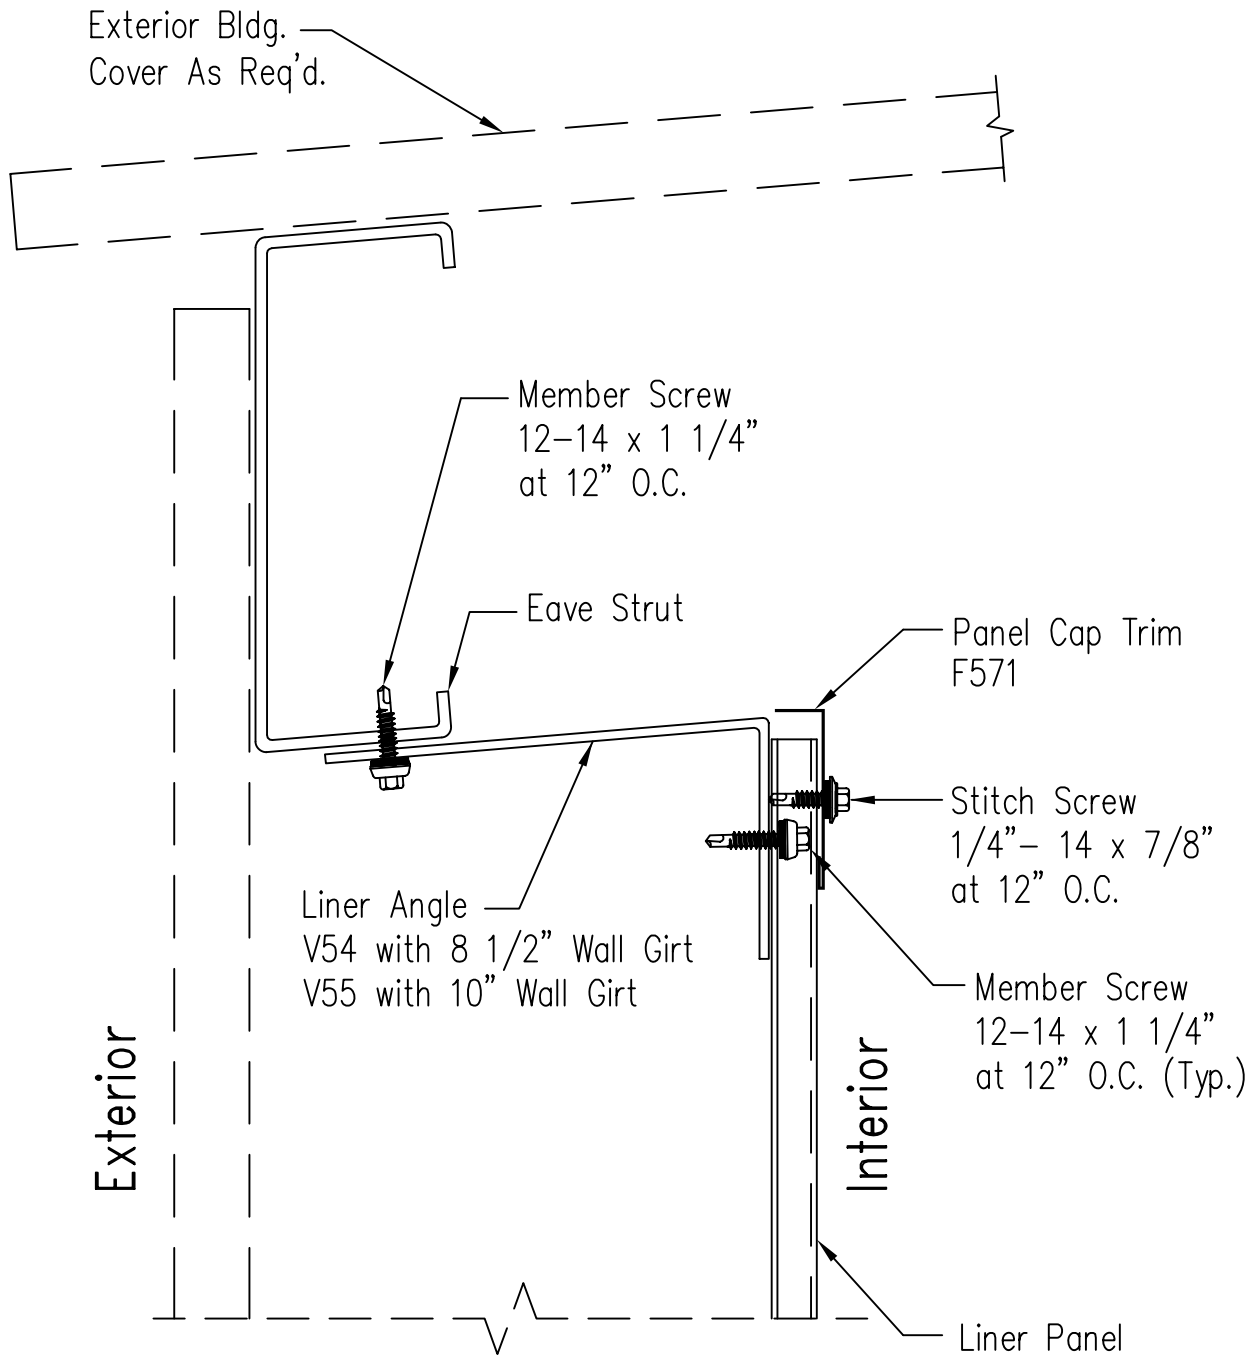
SHT. NO. UL01007	
DATE Oct. 09	REV. 01

Section At Eave

This drawing refers to liner conditions only. Refer to additional details for exterior sheeting and trim conditions.

PBU Wall Liner  
with PBU Roof Liner

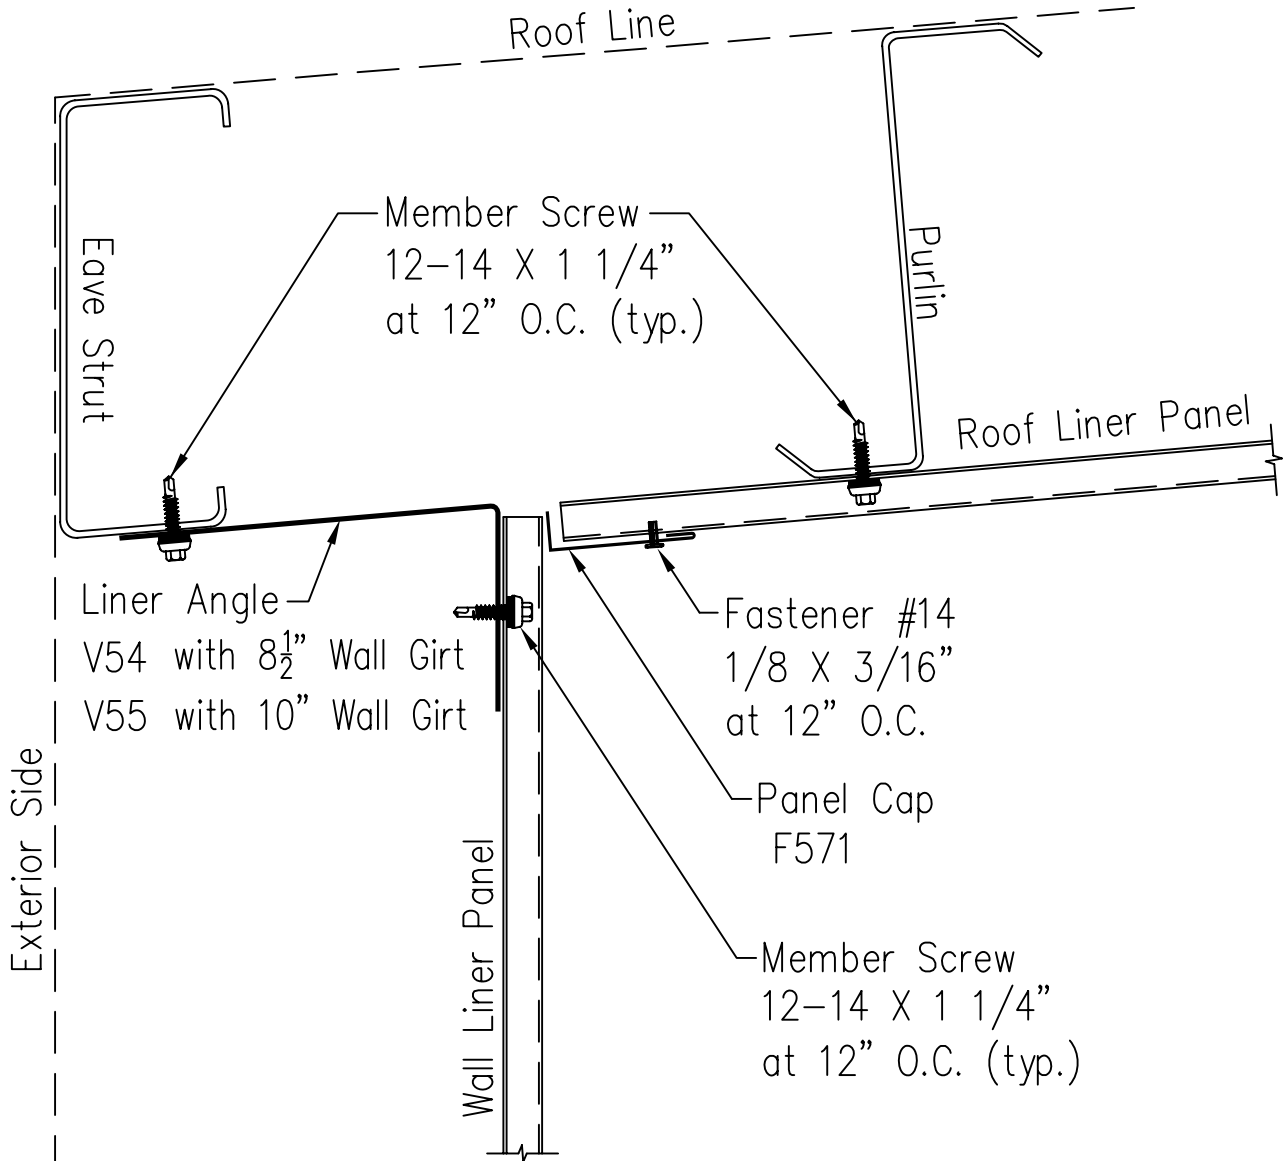
Note: This drawing refers to liner conditions only. Refer to additional details for exterior trim conditions.

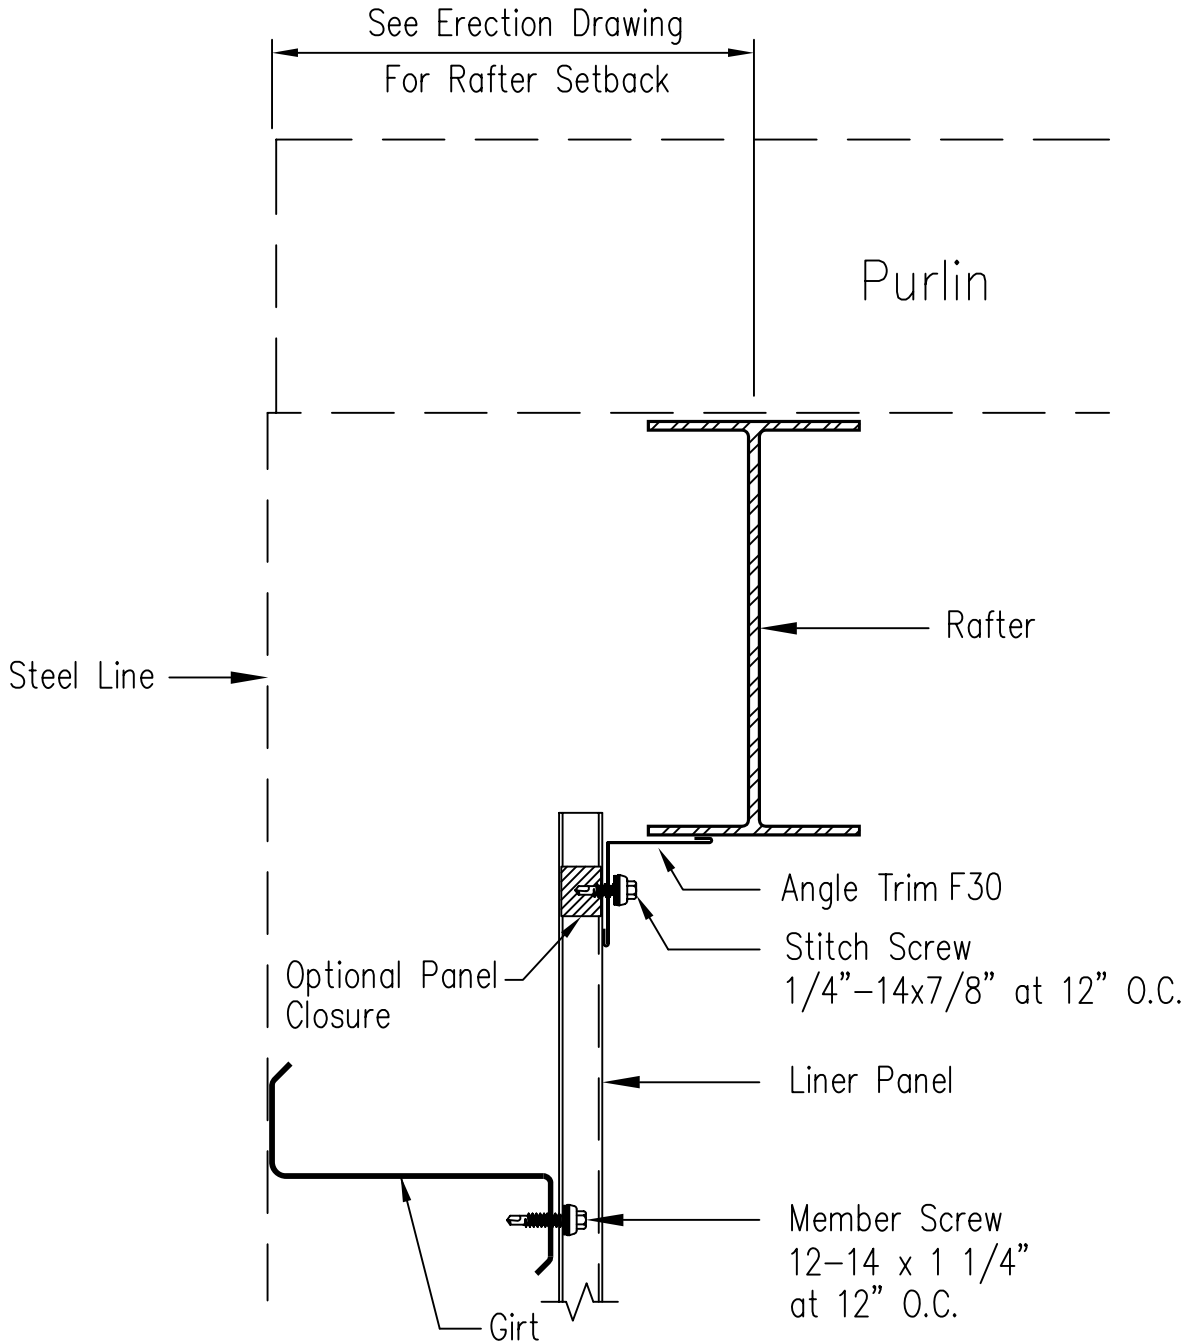
This drawing refers to liner conditions only. Refer to additional details for exterior sheeting and trim conditions.
